STATE OF THE ACT'S LAKES AND WATERWAYS 2011–2021: A TECHNICAL REVIEW

FINAL: February 2022

PREPARED FOR: *ACT Office of the Commissioner for the Environment and Sustainability*

Centre for Applied Water Science

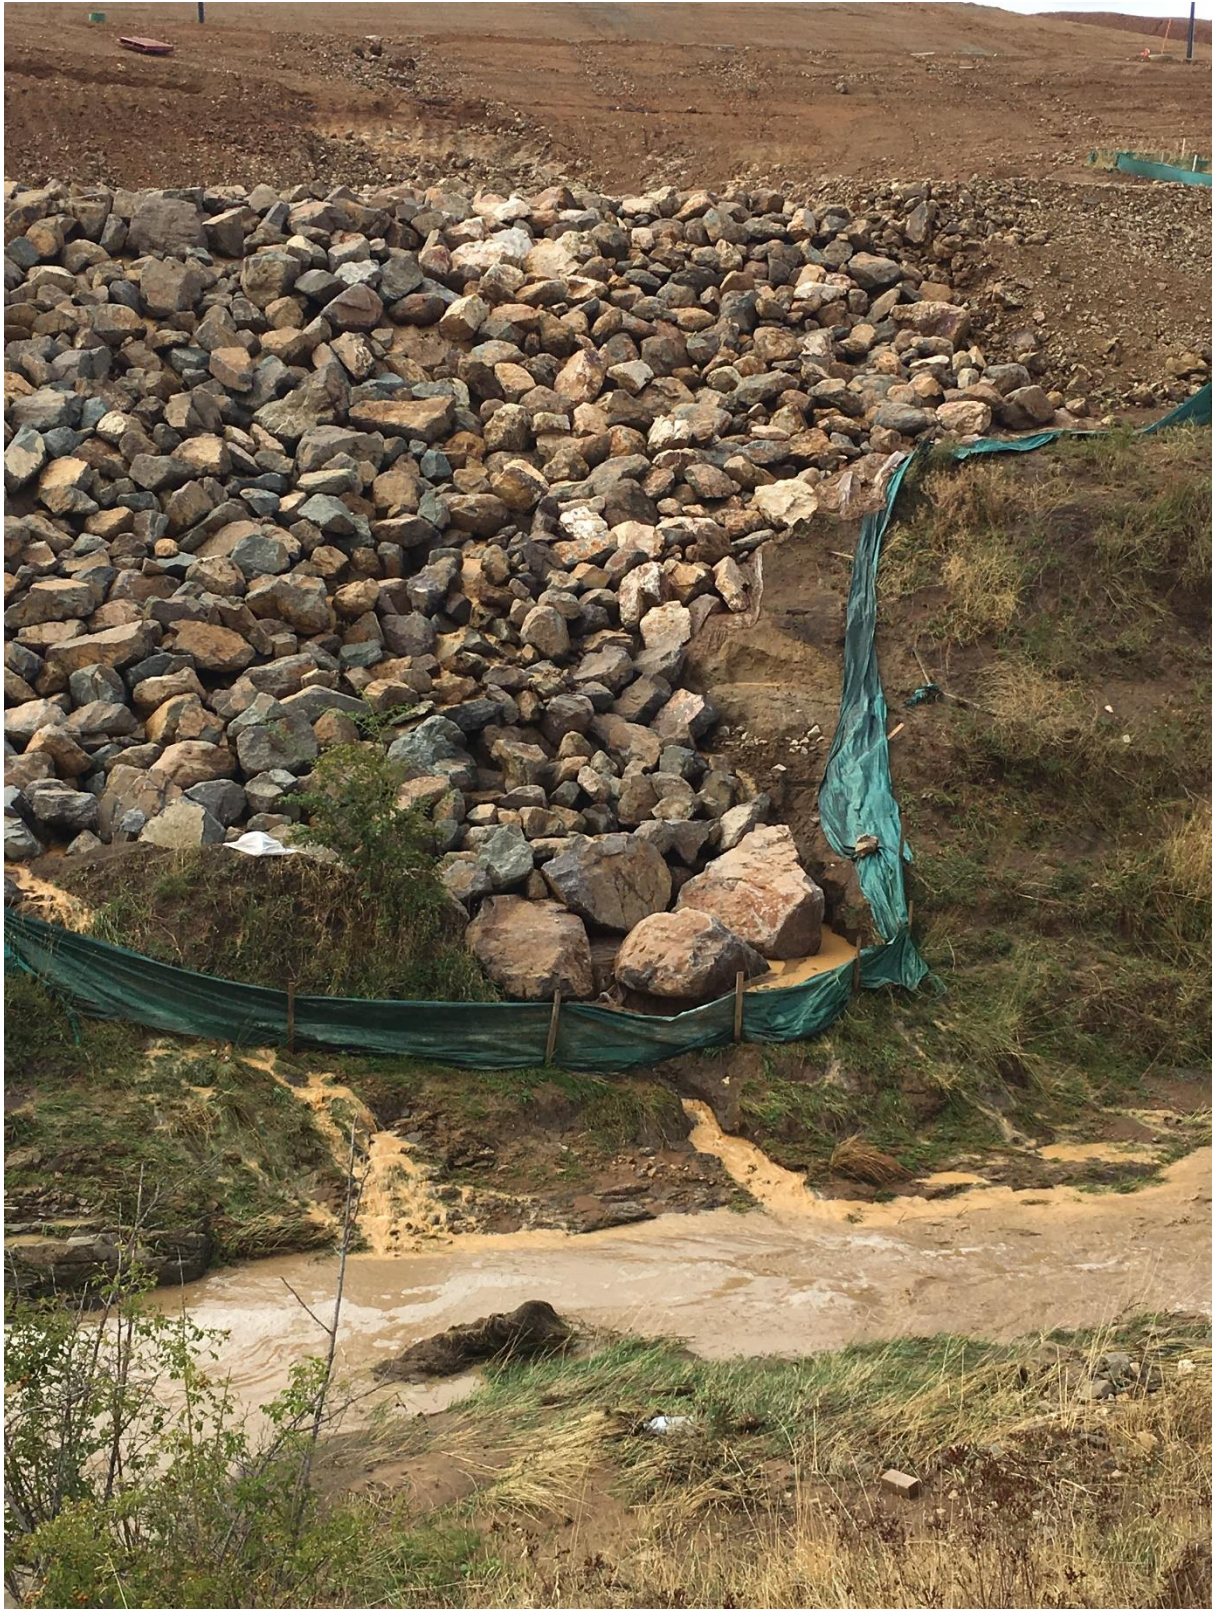
Figure 16. Sediment entering Deep Creek from construction areas, illustrating the failure of silt fencing to contain the mobilized sediment, February 2020. Source: ACT Waterwatch.

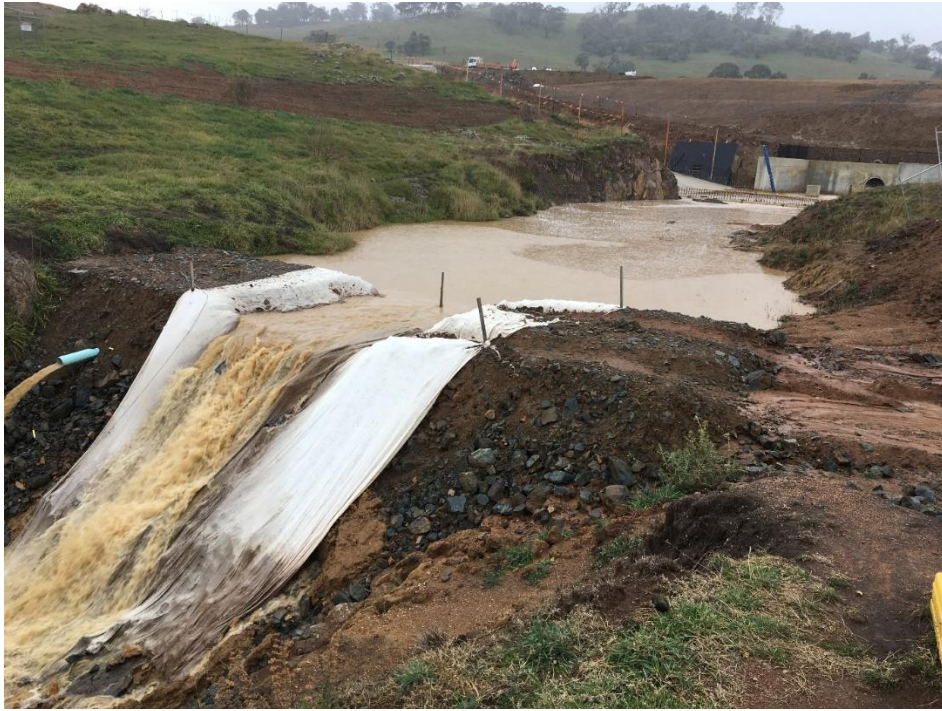
Figure 17. Deep Creek sediment detention pond illustrating the failure of the pond to trap fine sediments, June 2020. Source: ACT Waterwatch.

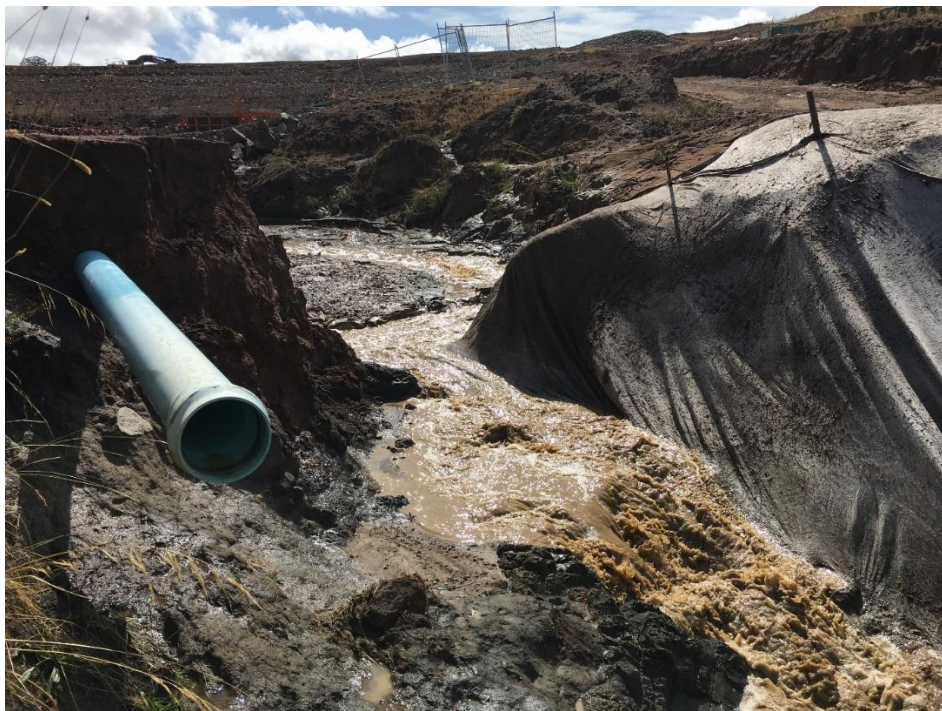
Figure 18. Failure of the Deep Creek sediment detention pond wall, February 2020. Source: ACT Waterwatch.

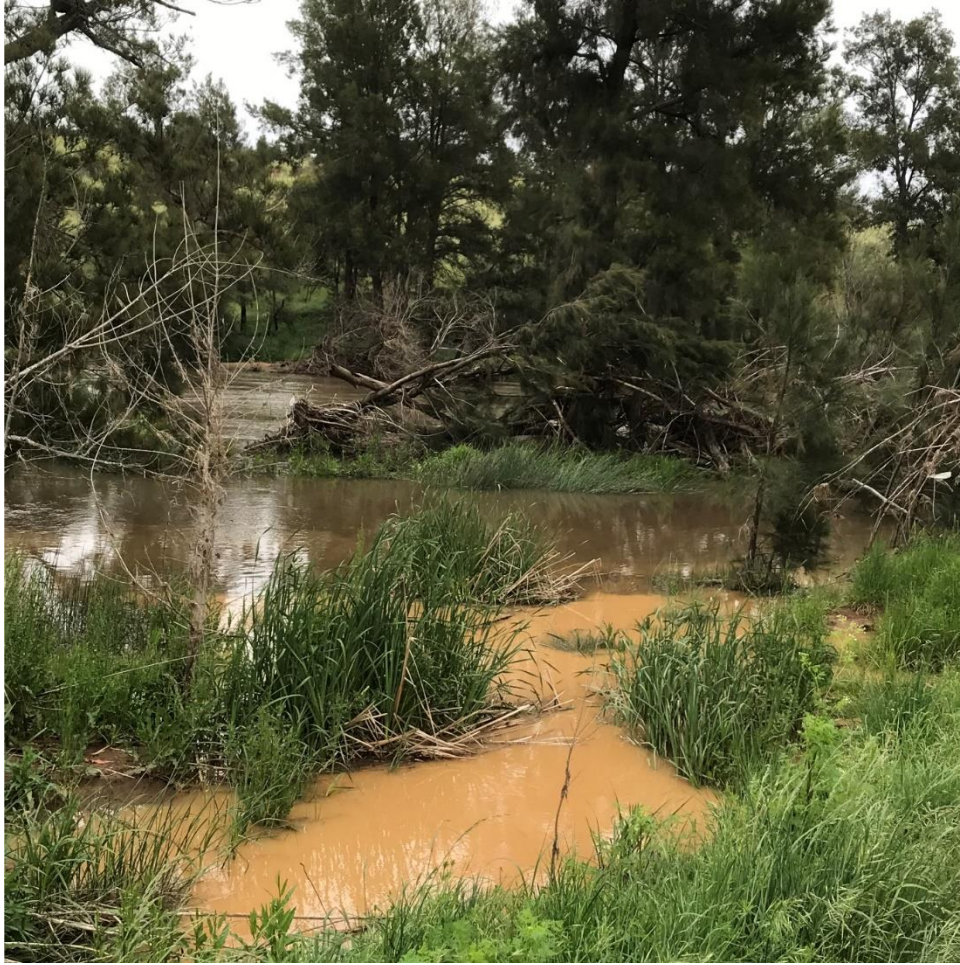
Figure 19. Deep Creek confluence with the Molonglo River. Source: ACT Waterwatch.

Despite the implementation of erosion control measures, high levels of sedimentation have been observed in Deep Creek since construction. Concentrations of suspended solids in Deep Creek are rarely within the acceptable range for ACT waterways (Figure 15) and often reach extremes of sediment concentrations. Sediment control infrastructure has been observed to be of very limited effectiveness (Figure 16) and the sediment detention ponds on Deep Creek have failed multiple times (Figure 17 and Figure 18), leading to high suspended sediment loads being delivered directly into the Molonglo River downstream of Lake Burley Griffin (Figure 19). While the Deep Creek

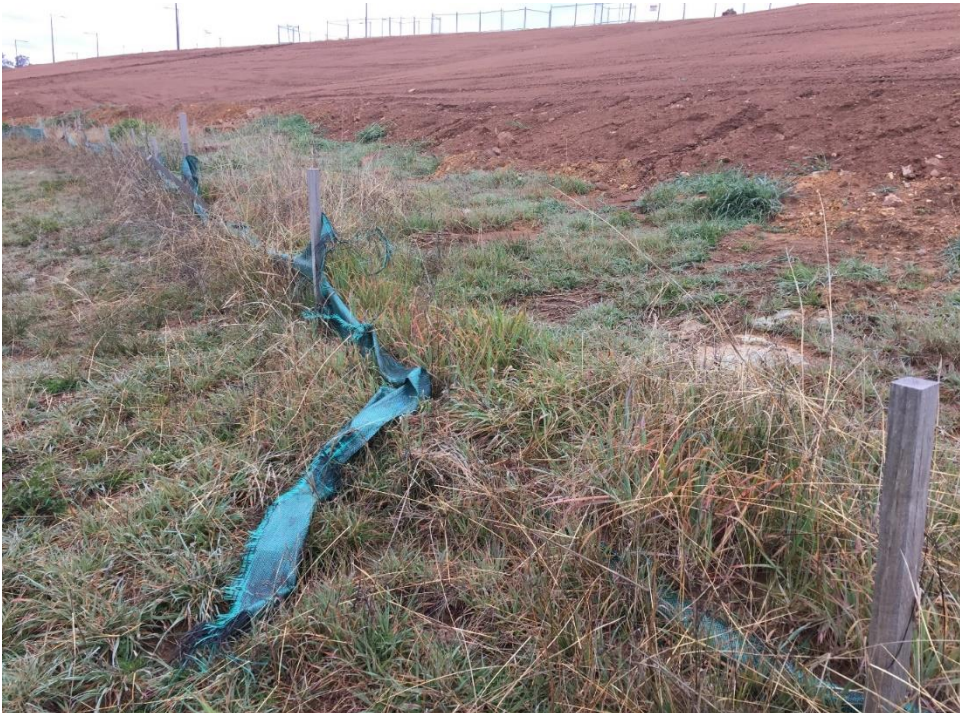
Figure 20. Poorly maintained silt fencing associated with urban development in the ACT. Source: ACT Waterwatch.

catchment is a particularly challenging site in which to control sediment runoff, failures of sediment control measures associated with construction in the ACT are not uncommon (e.g. Figure 20) and images of sediment laden urban waterways are not unusual (Figure 21).

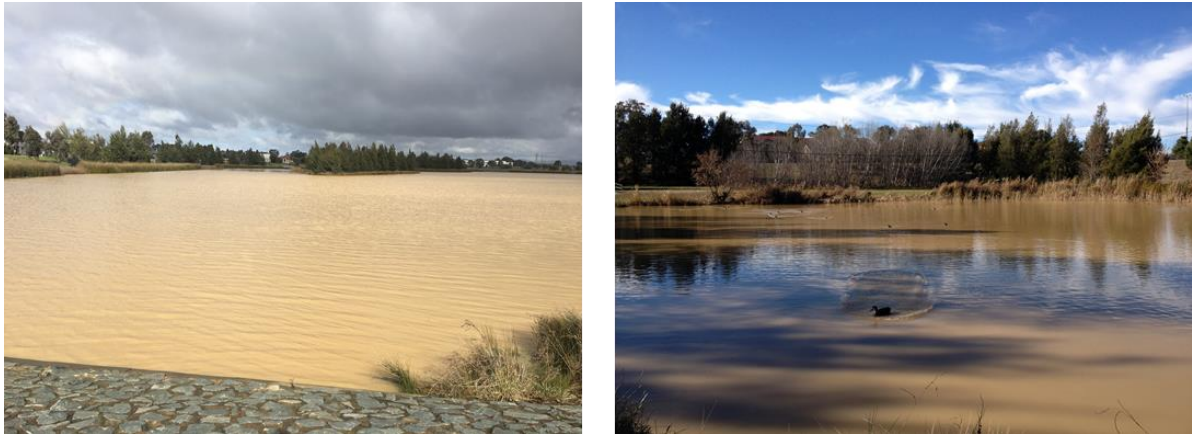
Figure 21. Sediment-laden water in Giralang Pond in June 2016 (left) and around the Casey Development in June 2013 (right). Source: ACT Waterwatch.
